# INTERMICO Index table

INTERMICO Index table

*Cam gears*

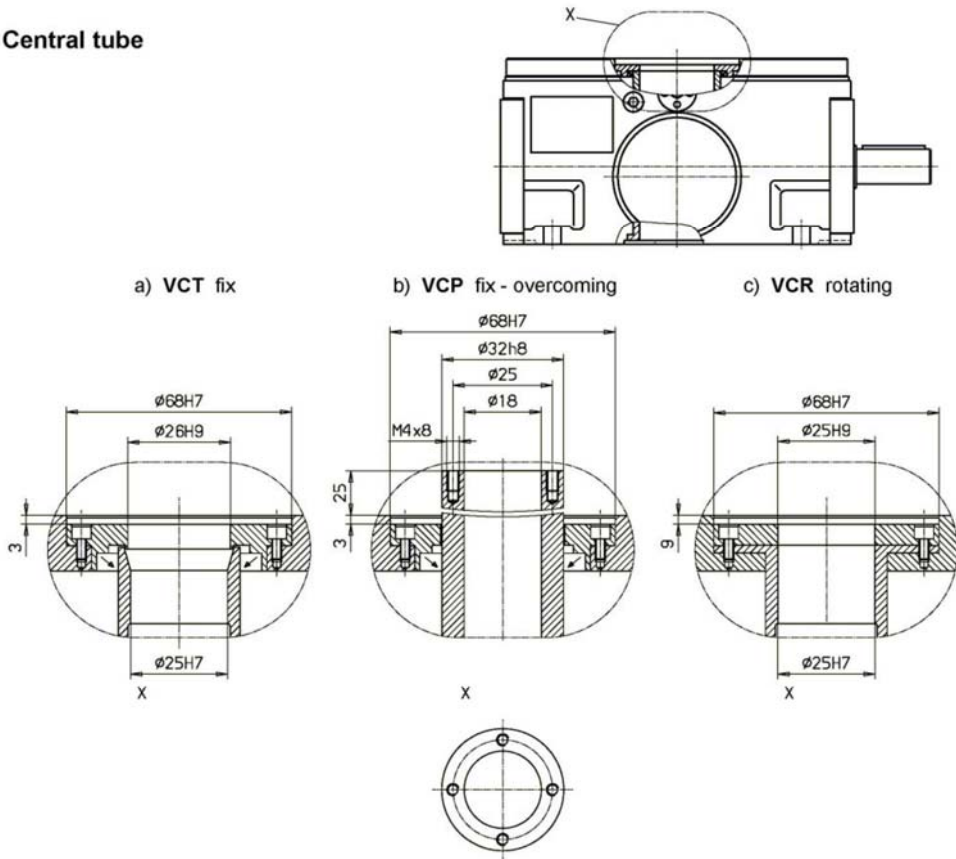
Central tube

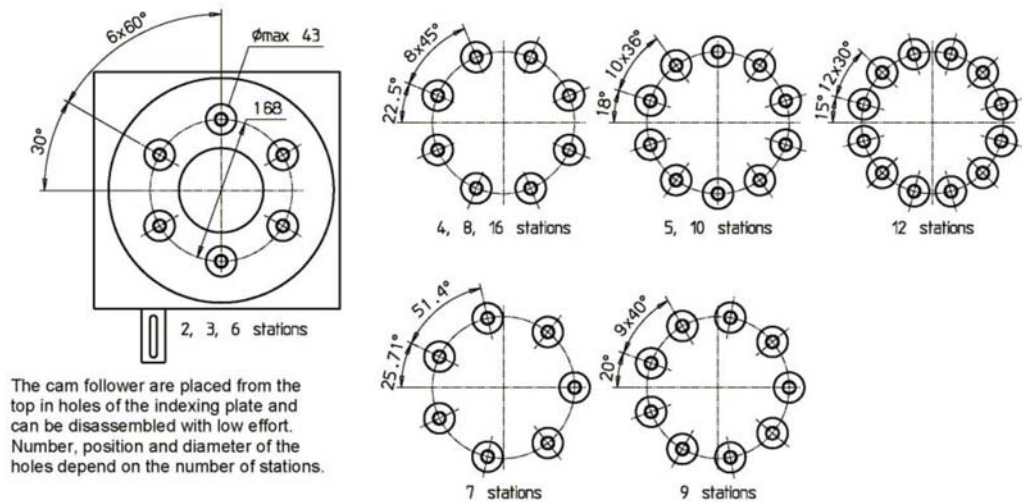
#### Position of the holes for the cam followers in indexing plate

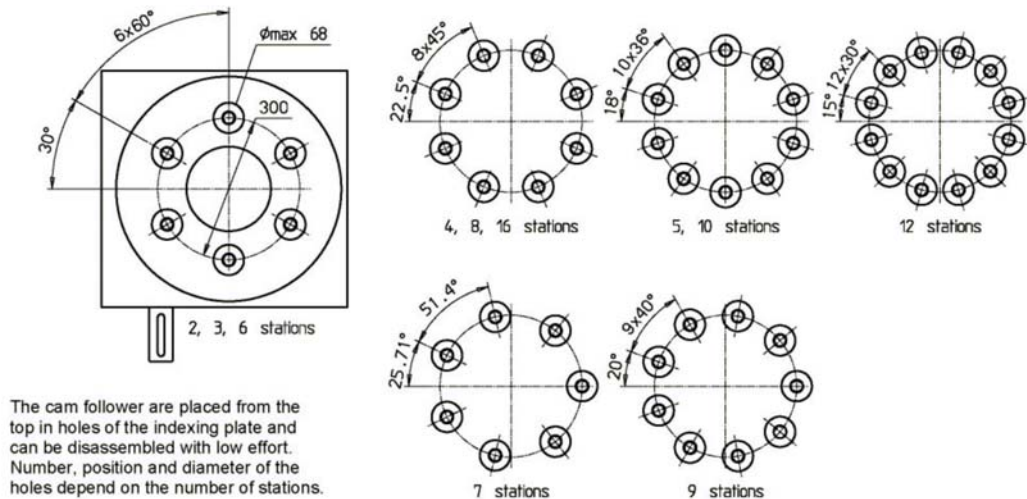
### Position of the holes for the cam followers in indexing plate

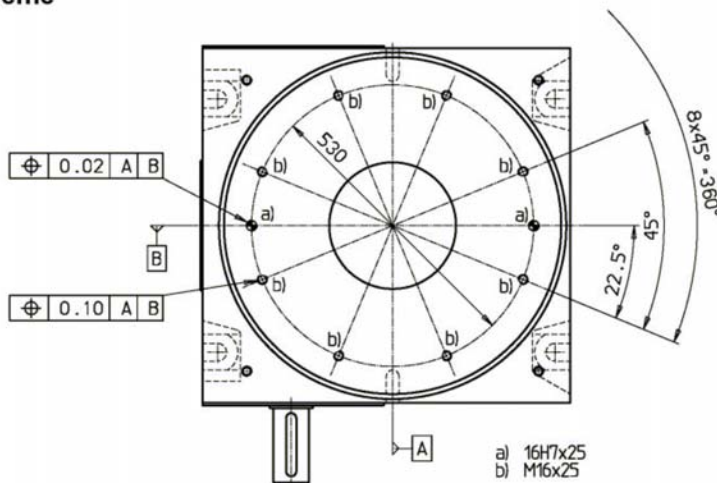
Drilling scheme
